DEPARTMENT OF TRANSPORTATION

Contract #: 04-0120F4Cty: SF/ALA Rte: 80 PM: 13.2/13.9File #: 13.28**WELDING INSPECTION REPORT****Resident Engineer:**Pursell, Gary**Address:** 333 Burma Road**City:** Oakland, CA 94607**Report No:** WIR-007899**Date Inspected:** 21-Jul-2009**Project Name:** SAS Superstructure**OSM Arrival Time:** 700**Prime Contractor:** American Bridge/Fluor Enterprises, a JV**OSM Departure Time:** 1530**Contractor:** Oregon Iron Works Clackamas, Or.**Location:** Clackamas, OR**CWI Name:** Mike Gregson, Jose Salazar**CWI Present:** Yes No**Inspected CWI report:** Yes No N/A**Rod Oven in Use:** Yes No N/A**Electrode to specification:** Yes No N/A**Weld Procedures Followed:** Yes No N/A**Qualified Welders:** Yes No N/A**Verified Joint Fit-up:** Yes No N/A**Approved Drawings:** Yes No N/A**Approved WPS:** Yes No N/A**Delayed / Cancelled:** Yes No N/A**Bridge No:** 34-0006**Component:** Hinge K Pipe Beams**Summary of Items Observed:**

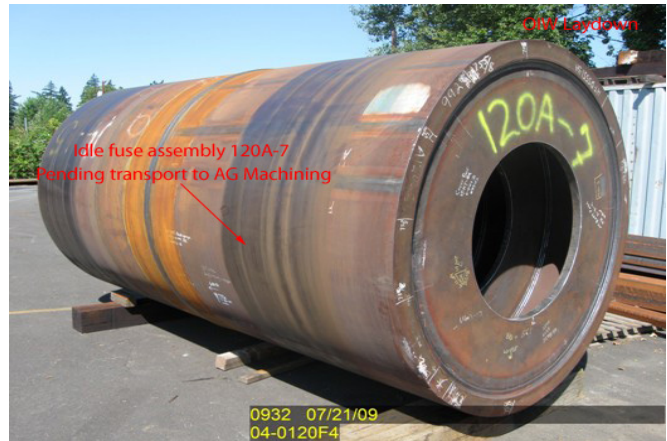
Hinge-K Pipe Beam Fuse Assembly 120A-7: 7/21/09

QA Inspector noticed the submerged arc welding on the CJP (AWS D1.5 B-U3c-S) weld splice, sub-assemblies identified as (a124-5/a124-15), weld joint identified as WM3-18, for fuse assembly 120A-7, had been previously completed and QC Inspector Rob Walters had performed 100% final ultrasonic weld inspection and this assembly 120A-7 was sitting idle. QA Inspector reviewed the applicable ultrasonic testing report, after completion of the ultrasonic weld inspection and noted that Mr. Rob Walters had performed the inspection utilizing a 60 and 70 degree transducer angle on the exterior (face "A") and a 60 degree transducer angle on the interior (face "B") and found no rejectable indications. QA Inspector noted that Mr. Walters appeared to be in compliance with AWS D1.5 and contract requirements. See attached picture below.
